MARINE INVESTIGATION REPORT

M00M0083

UNCONTROLLED DESCENT OF FREIGHT ELEVATOR

FREEZER TRAWLER MERSEY VENTURE

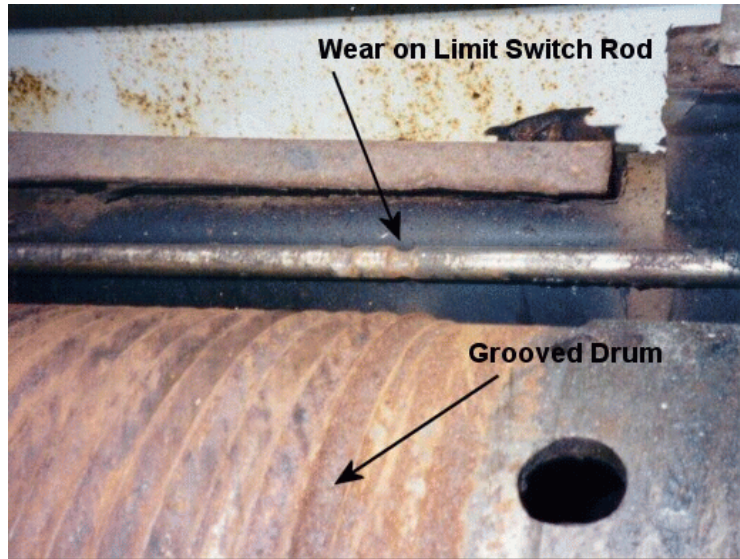
Photograph 3. Limit switch rod.

The general appearance of the drum, at the time of the occurrence, indicated the rope hoist had not been maintained to the standard required for this type of hoisting machinery. The wires in the suspension systems and drum were rusted in places and without lubrication. Experienced elevator mechanics, familiar with this type of unit, cite the lack of lubrication on the rope guide as a possible cause of wire nipping. There are no maintenance records for the rope hoist. It was not possible to determine exactly what, if any, preventative or ongoing routine maintenance was done.

Secondly, the rope guide operates the primary stage limit switches when the desired hoisting or lowering height has been reached. On installation of the hoisting unit, the set rings were adjusted to the correct position on the limit switch rod so that as the rope guide moved along the rope drum and reached its preset maximum travel. The rope guide would strike a set ring and cause the limit switch rod to move in the same direction, activating the limit switch.

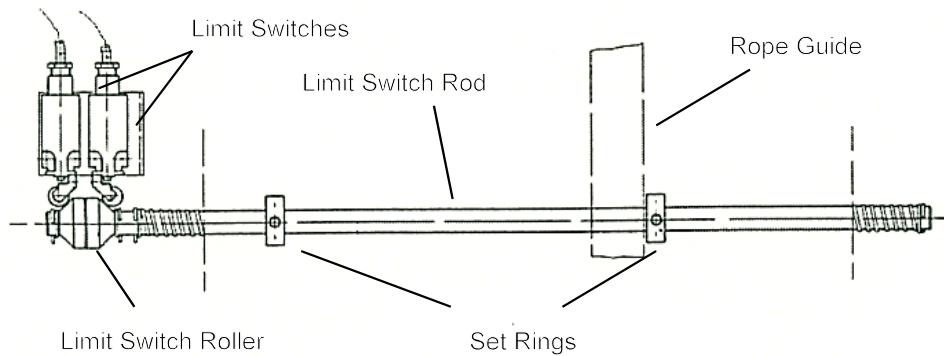
Figure 1. Limit switch equipment

Firstly, when the hoist is being operated, the rope guide moves in an axial direction along the rope drum, following the movement of the load rope and ensures that the rope is laid accurately in the rope drum groove. With the rope guide removed, the wire rope is not consistently or accurately laid in its groove on the rope drum. The wire rope can jump grooves and cause riding turns.

Removal of the rope guide had two consequences.

Firstly, the wire rope was not accurately laid in the rope drum grooves, causing riding turns of the wire and a slack wire.

Secondly, the primary stage limit switches were rendered inoperative.

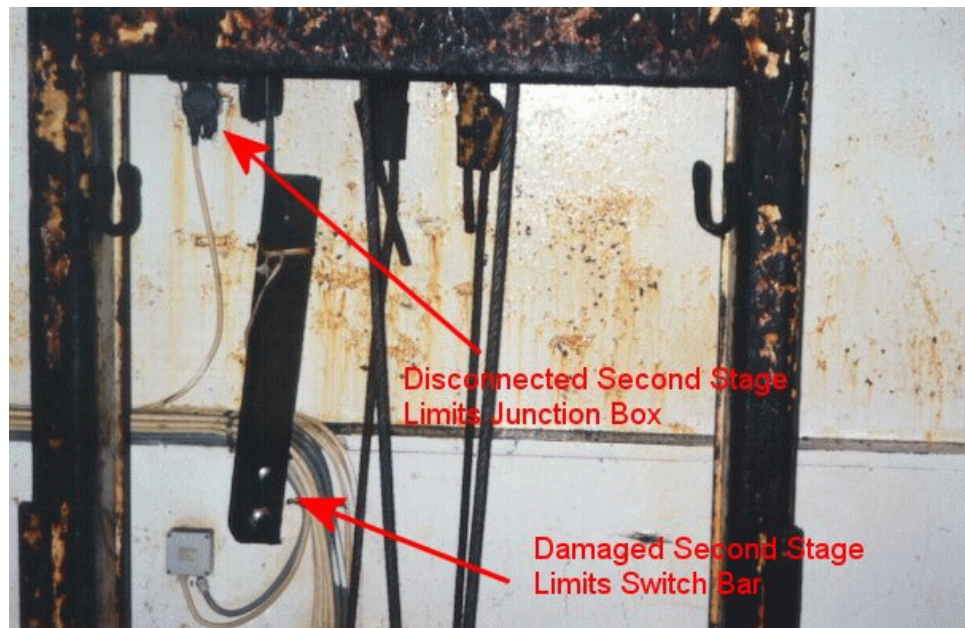
Photograph 4. Secondary stage limit switch

However, it is usual for elevator installations to have a secondary stage limit system as a redundant failsafe to the primary stage limits. The upper secondary stage limit system, as originally fitted, was a configuration of two magnetic proximity switches installed in series and mounted on an angle iron support bar. The bar was mounted so that the switches would sense the presence of the platform and de-energize the system.

At the time of the occurrence, the proximity switches had been disconnected. The angle iron bar was suspended on a length of nylon twine, such that when the platform was at the upper terminal and level with the factory deck, the bar would strike the top of the cross piece adjacent to the port side sheave on the platform. In this configuration, the bar was being used as a visual cue for the operator to stop the platform by releasing the 'up' push button switch.

Experience shows that magnetic proximity switches are prone to failure under severe operating conditions. When in normal operation, the platform cycles between the heat and humidity of the factory deck and the minus 30°C temperature of the hold, causing ice and frost to build up on the exposed metal surfaces of the elevator. When the

elevator was repaired and placed back in service after the occurrence, five of the six proximity

switches installed in the system at the time of the occurrence were inoperative or missing and required replacement. Both proximity switches in the upper final stage limits were replaced.

If the secondary stage limit switches fail while the operator is relying on them to de-energize the rope hoist, the elevator platform will continue rising until it contacts the bottom of the angle iron bar on which the proximity switches are mounted. This would most likely cause the angle iron bar to deflect and break off at the connection to the elevator frame. Sometime after a Transport Canada Marine Safety (TCMS) inspection in 1996 and prior to the occurrence, this sequence of events likely occurred since the bar was detached at its base from the elevator frame.

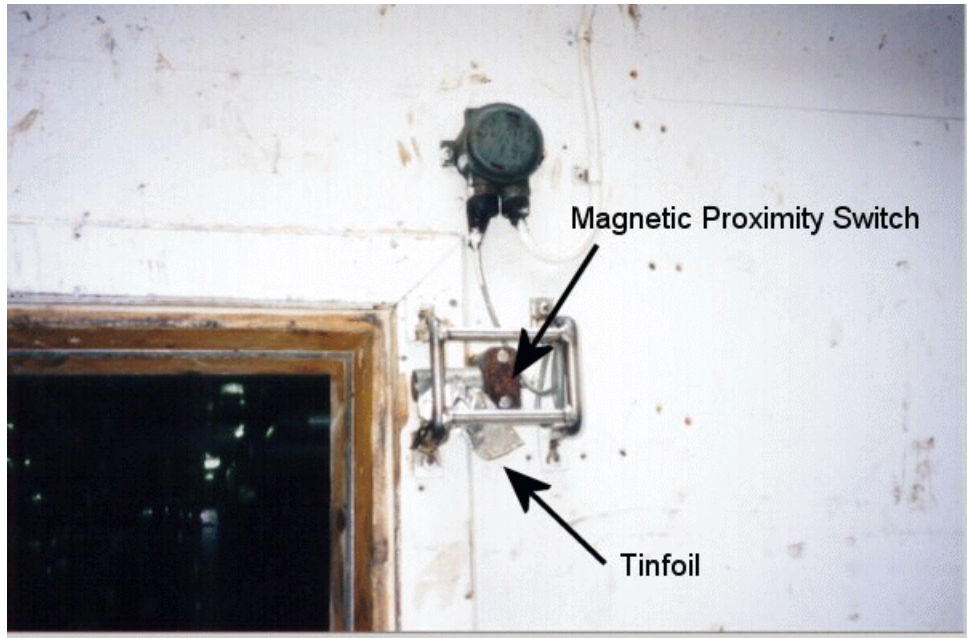
Photograph 5. Disabled magnetic proximity switch

The elevator hoistway at the factory deck level is enclosed on all four sides. A door to enter the hoistway is located on the after bulkhead of the hoistway. A proximity switch is installed to prevent operation of the elevator with the door in the open position. Although not causal, it was discovered by NSDL-OSH division during the initial investigation that a

piece of tinfoil had been folded around the sensor, defeating the proximity switch and allowing the elevator to operate in an unsafe condition. This became an accepted routine situational adaptation done to allow easier access to the elevator hoistway.

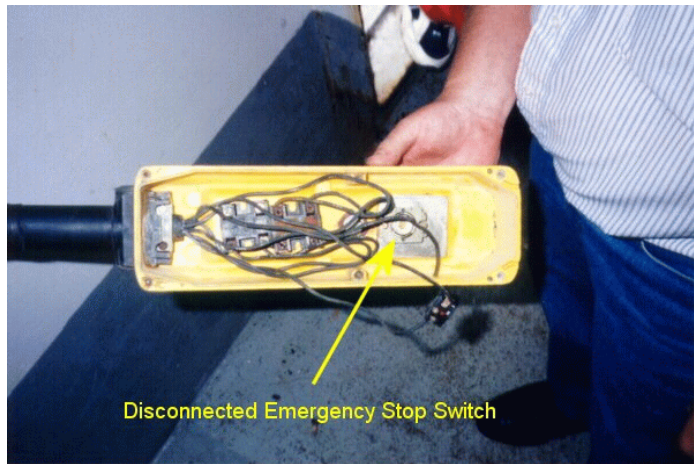
Photograph 6. Disconnected emergency stop switch

The elevator is operated from the factory deck level using a wander lead (or pendant) with three spring-loaded control buttons: raise, lower and emergency stop. To raise and lower the elevator platform, the operator must push and hold the buttons as required. The elevator platform will travel in the desired direction, stopping when the operator releases the button. The elevator can be stopped at any point along its travel between the two terminals. Activation of the emergency stop on the wander lead has the same effect as opening one of the limit switches and is fitted to counter the failure of one of the raise/lower buttons also located on the lead.

Earlier in the year, the stevedores had experienced some problems with the wander lead and temporary repairs were effected. Upon examination by NSDL-PSD, it was discovered the emergency stop button on the wander lead was not connected. It was not however, causal in this occurrence.
